# Tree Survey Report

## **DEESIDE GOLF CLUB BIELDSIDE ABERDEEN**

December 2024

Struan Dalglish Arboriculture  
The Bothy  
Drumoak  
Aberdeenshire  
AB31 5EP

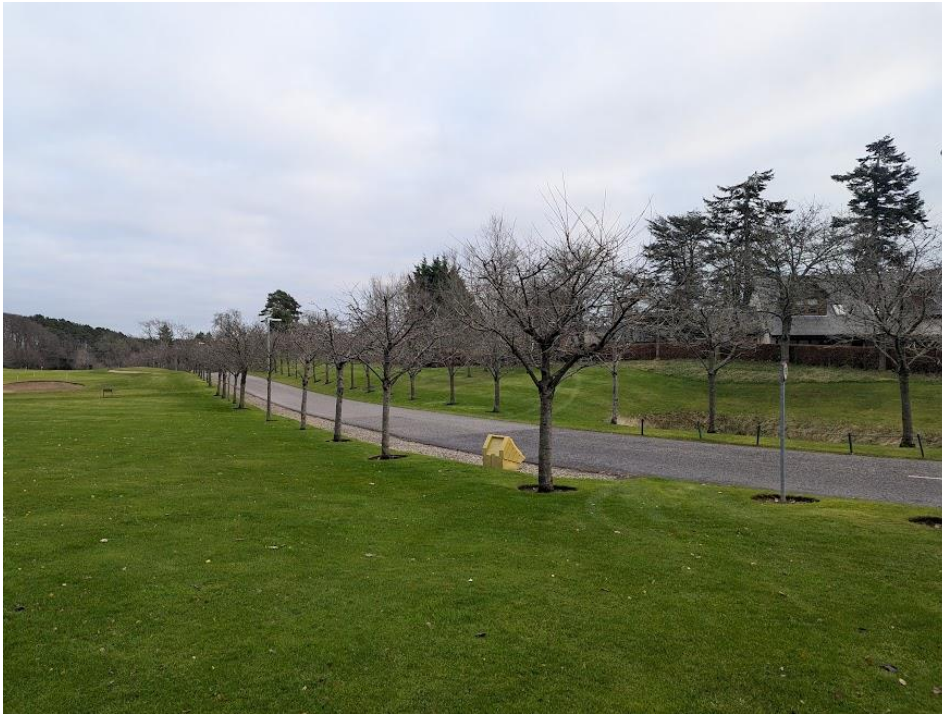
Photo 1 – G1, cherries lining the driveway.

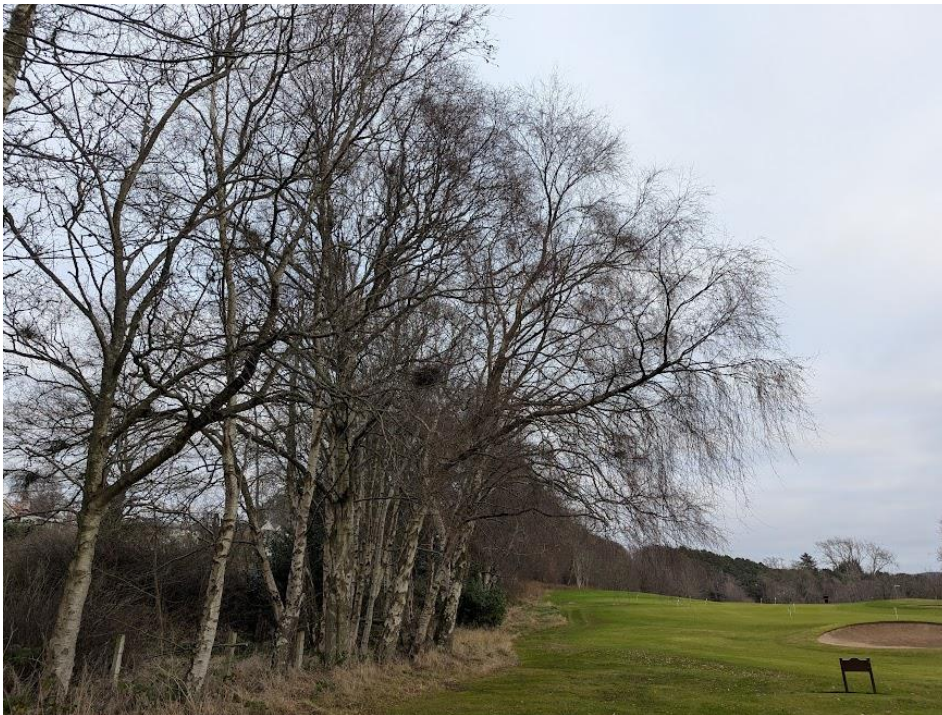
Photo 2 – Birch in G2 overhanging practice area adjacent to Deeside.

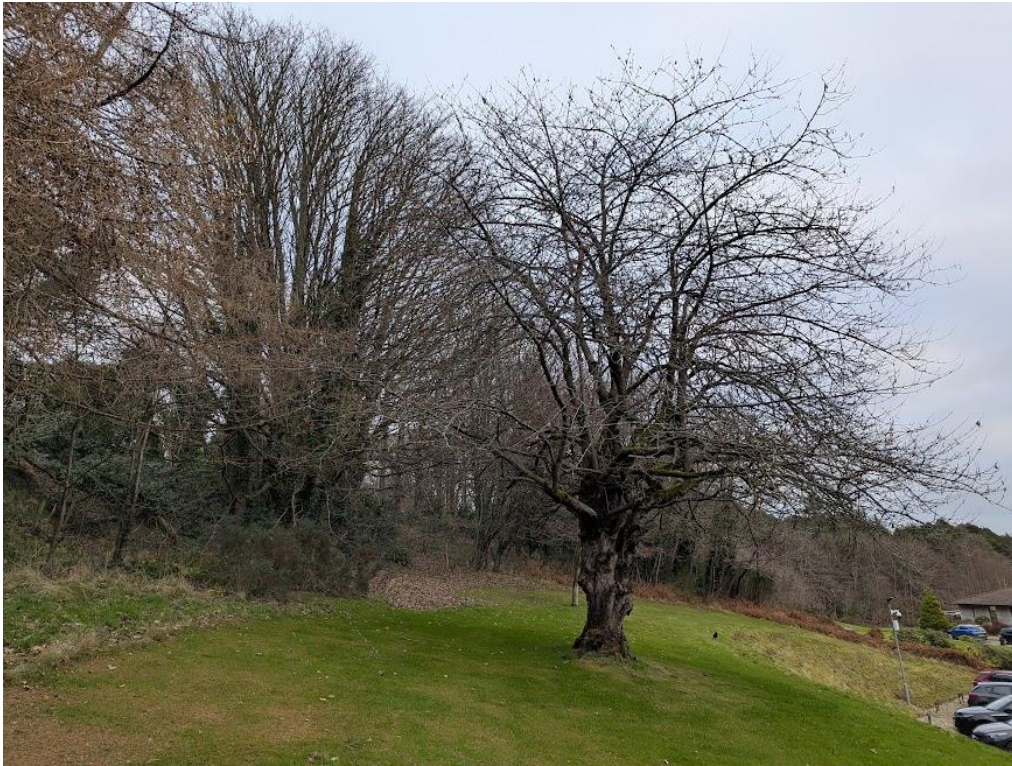
Photo 3 – Mature cherry between car park and Group 4.

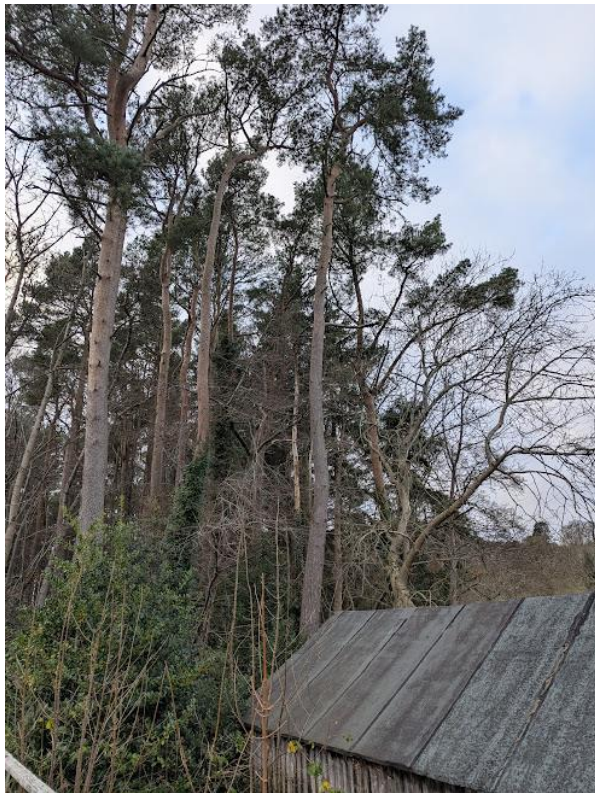
Photo 4 – Conifers at edge of G8 close to neighbours house and garden buildings.

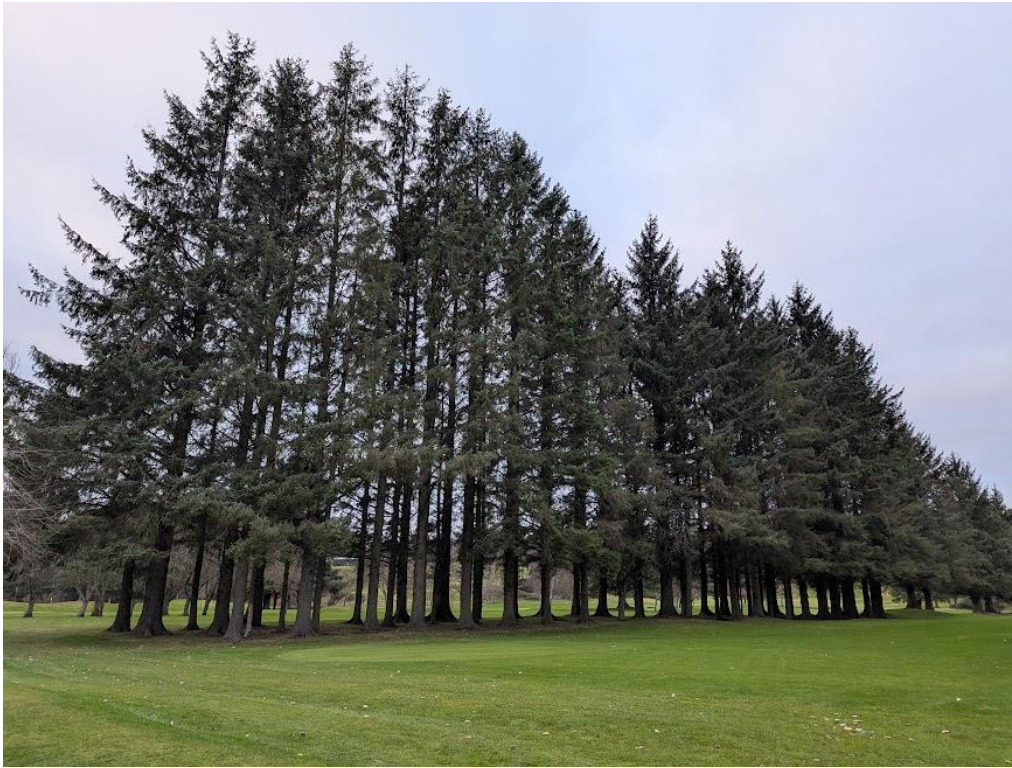
Photo 5 – Mature spruce lining fairway.

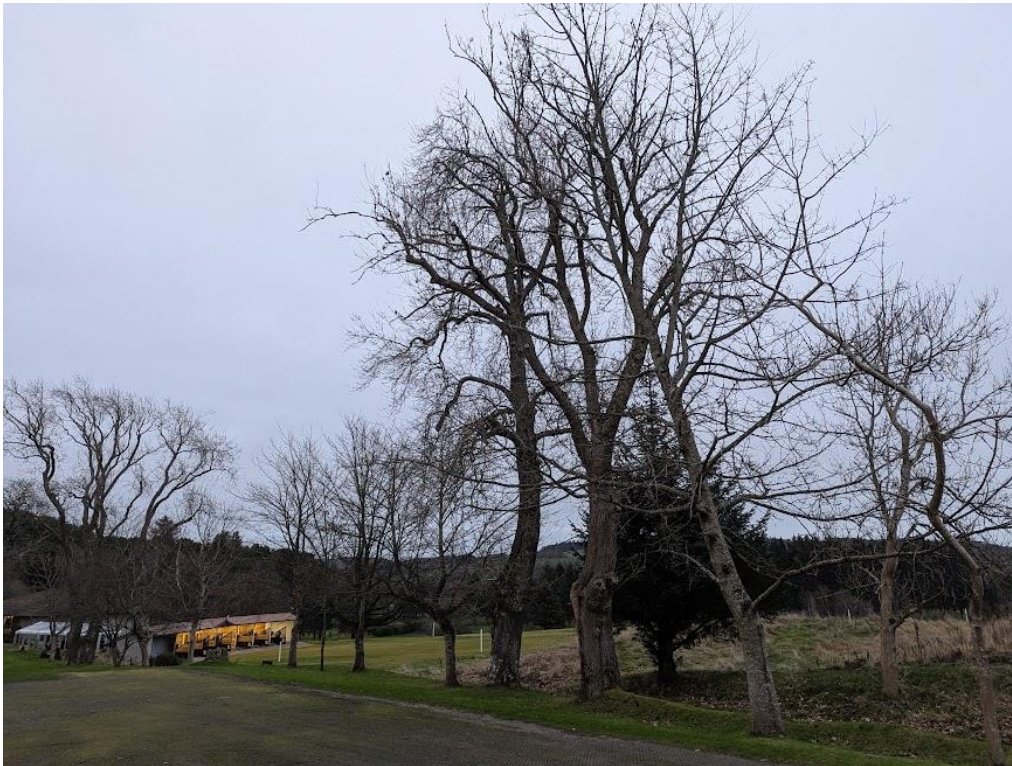
**Ash 848** was noted to have significantly died back since 2022. The old tree, which overhangs car parking has a large hollow cavity in the lower trunk.

Photo 6 – Mature ash 848 displays significant tip dieback and pruning to reduce the crown by 25% is recommended to remove dead branches.

Pruning to reduce the crown by a further 25%, removing the dead ends is recommended.

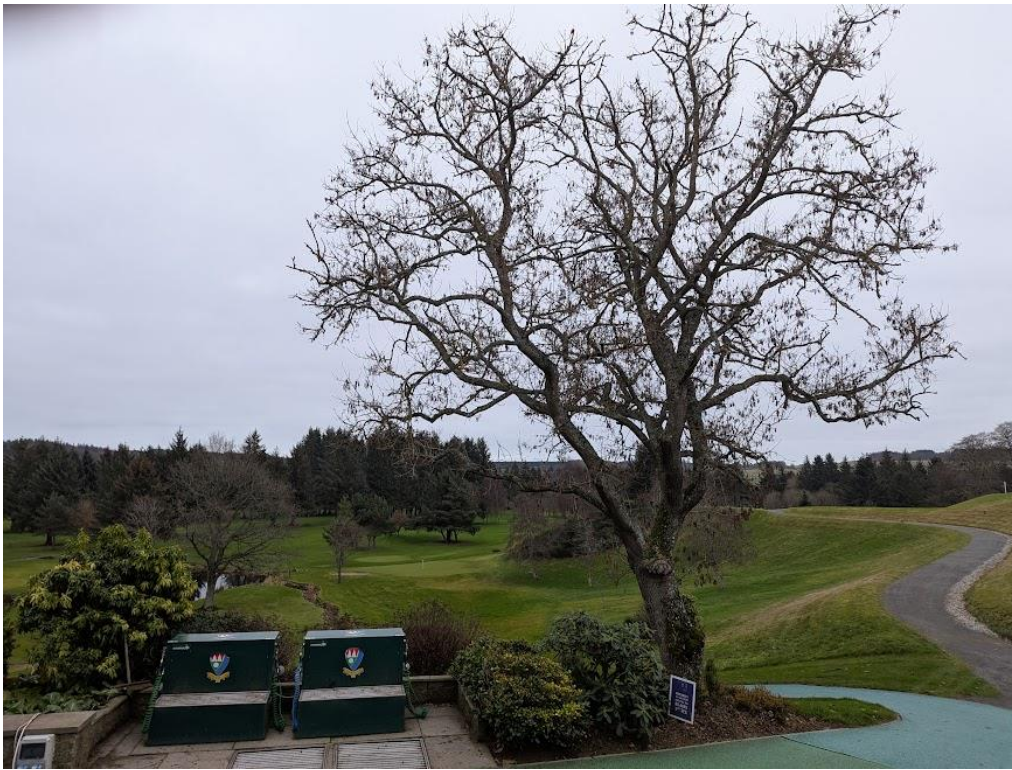
Photo 7 – Ash 416 next to clubhouse. Tip dieback was previously noted and does not appear to have significantly progressed. Ash trees should be re-inspected during the summer months.

Ash trees should be re-inspected for dieback disease when in leaf and symptoms are most evident.

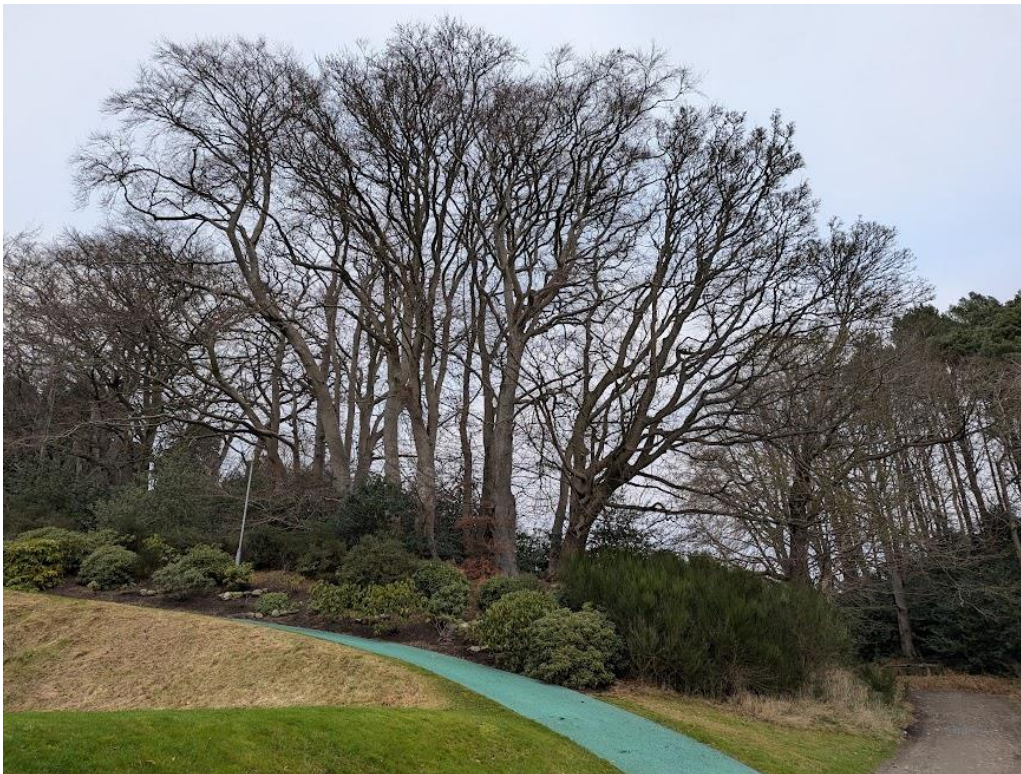
Photo 8 – Mature beech 148, sycamore 147 and Norway maple 132 at edge of G6.

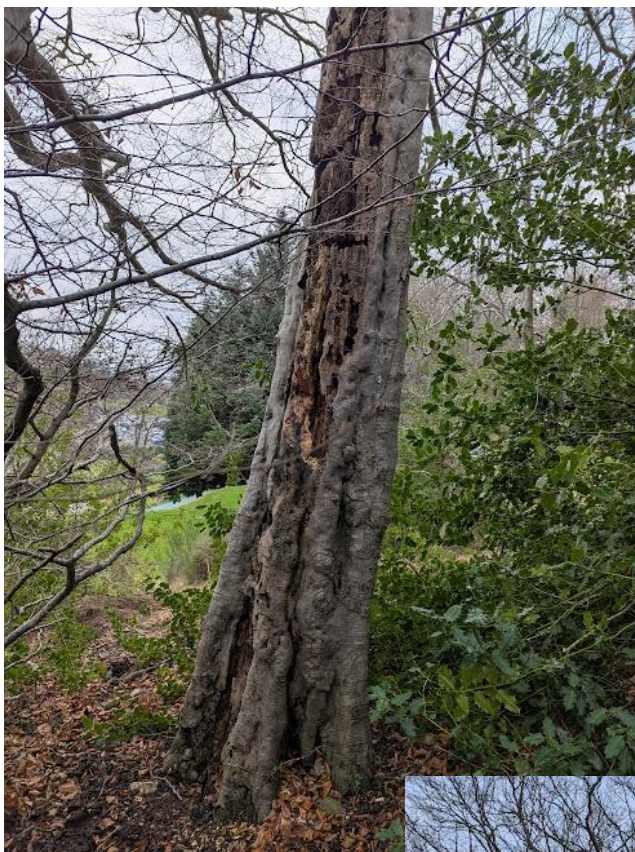
Photo 9 – Severely decayed beech 149 within G6.

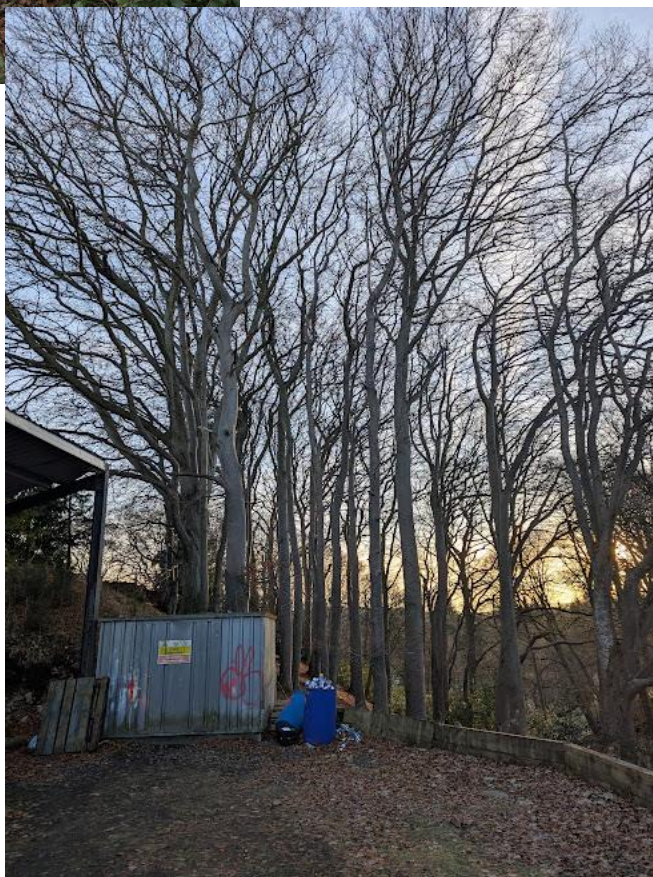
Photo 10 – Beech at edge of G11, close to greenkeepers facilities.

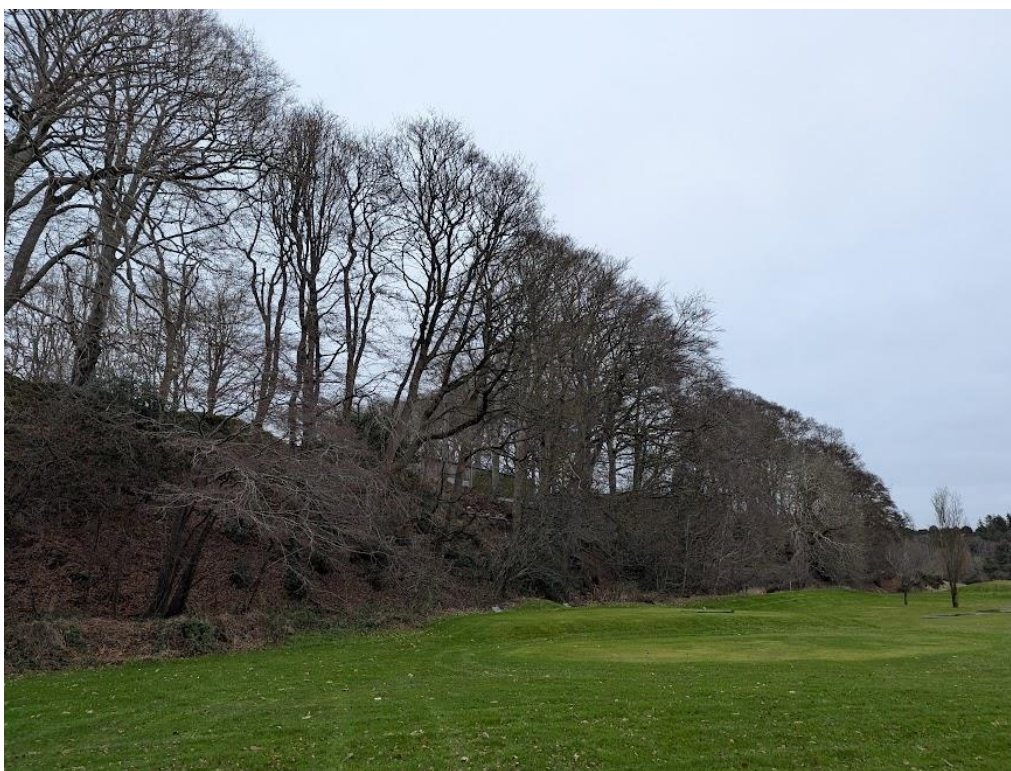
Photo 11 – Trees mature trees, often beech on embankment at edge of G11.

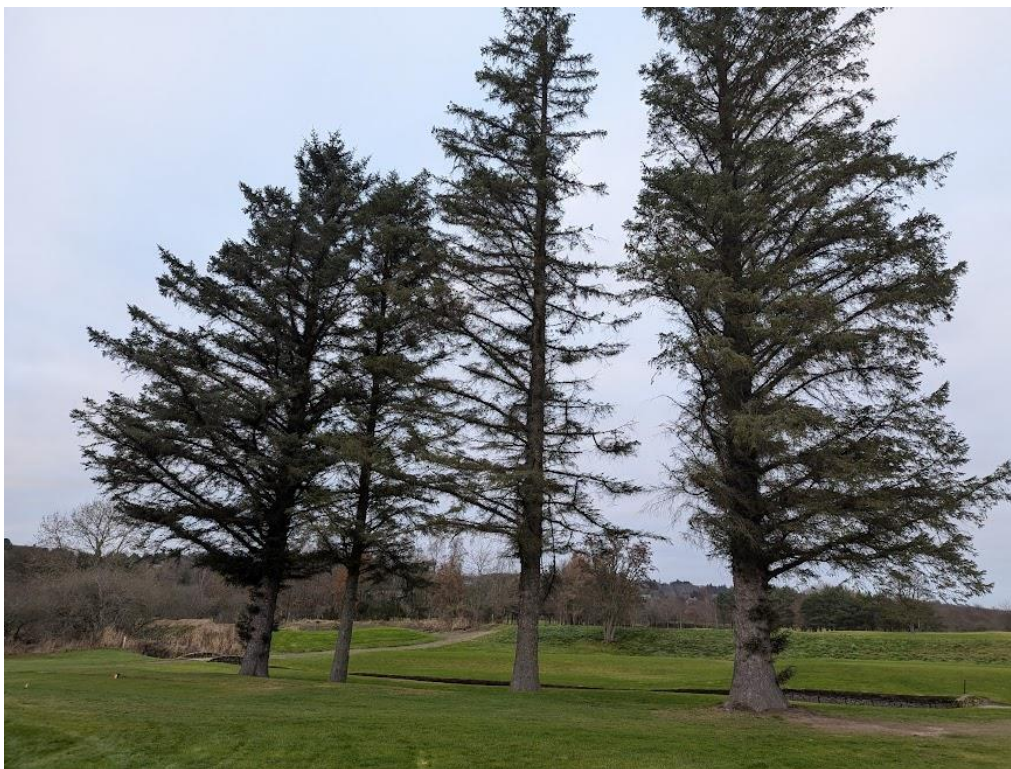
Photo 12 – Sitka spruce in G50. Dead tree has been removed.

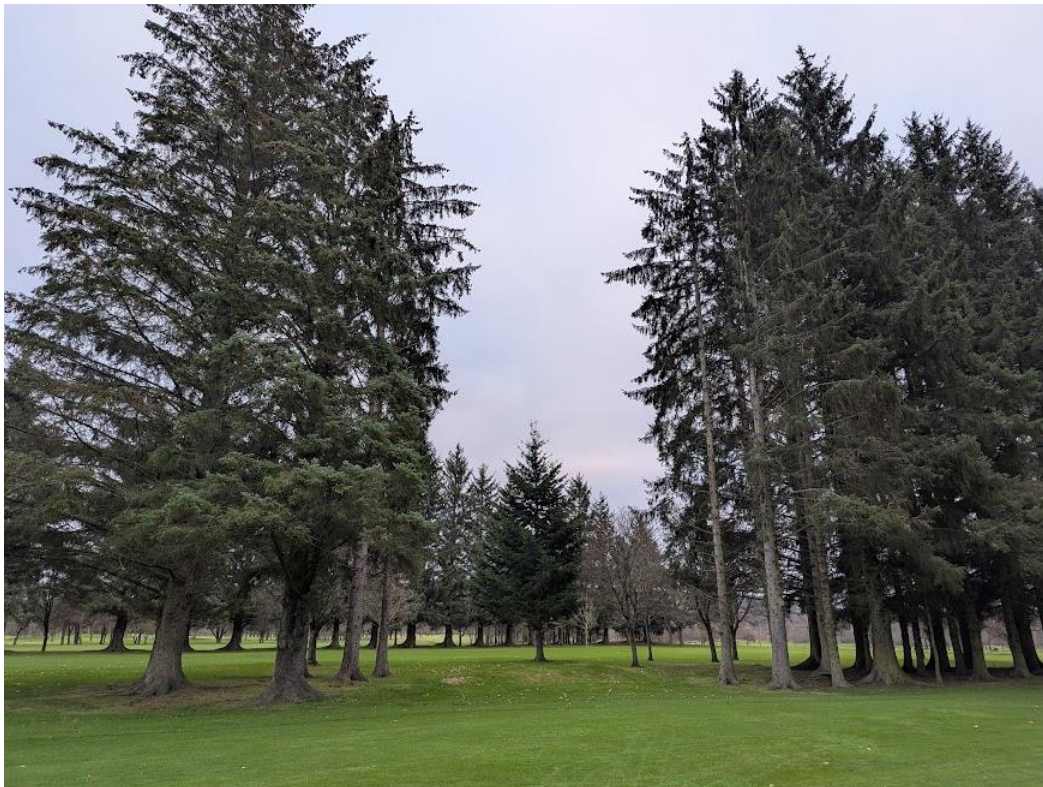
Several mature Sitka spruces blew over during very high winds in 2014 and tree inspection at that time confirmed the presence of the root decay fungus *Heterobasidion annosum* within Group 45. The trees within this group and neighbouring groups 44 and 47 were tagged at the time. These tags remain in fair condition.

Photo 13 – Gap in G45 where trees previously blew over and were removed. No further windblow has occurred since this time.

To ensure safety of golfers from falling trees during gales access to the course or parts of the course, in particular adjacent to Groups 44 and 45, could be restricted.

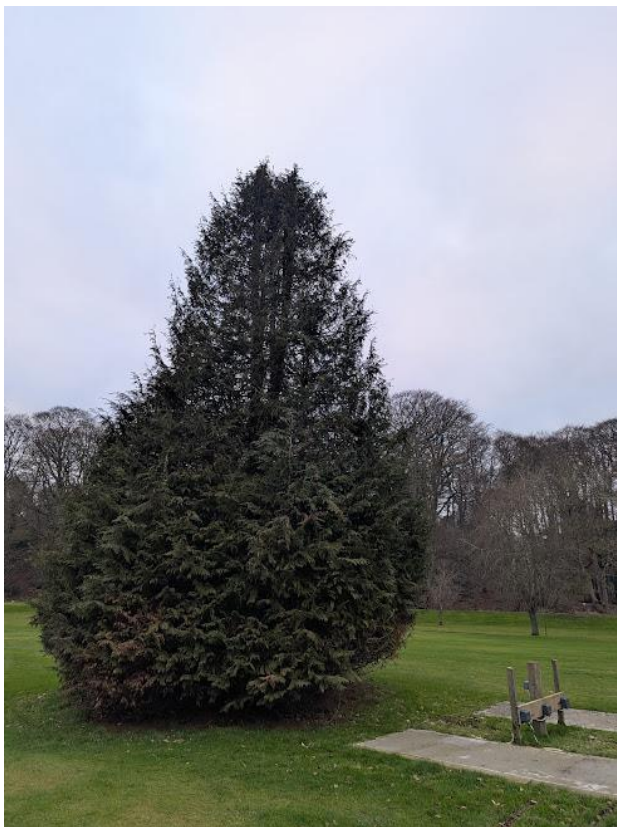
Photo 14 – Lawson cypress 130, near G27. Crown is thinning.

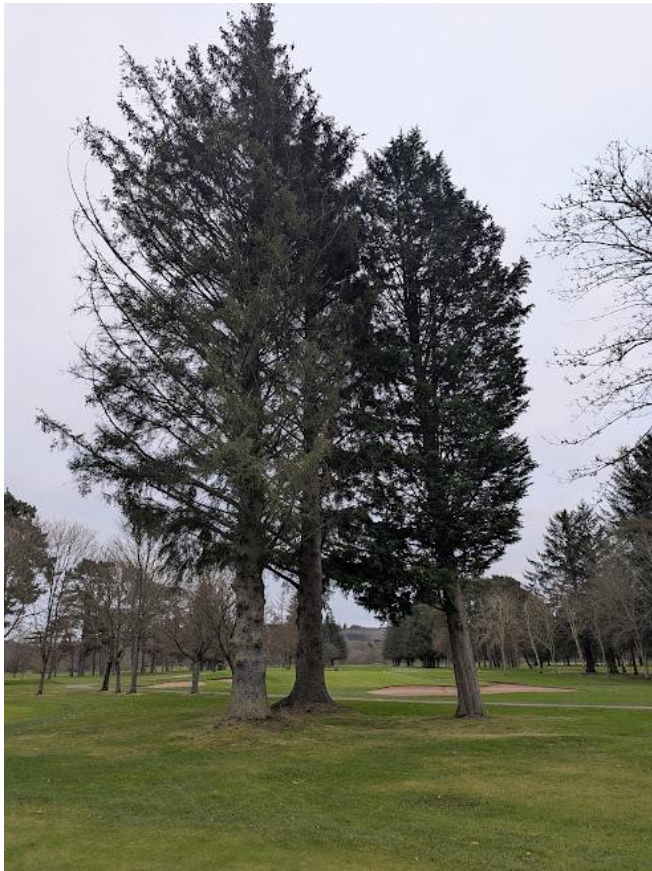
Photo 15 – Spruce 131 in G27 display significant thinning.

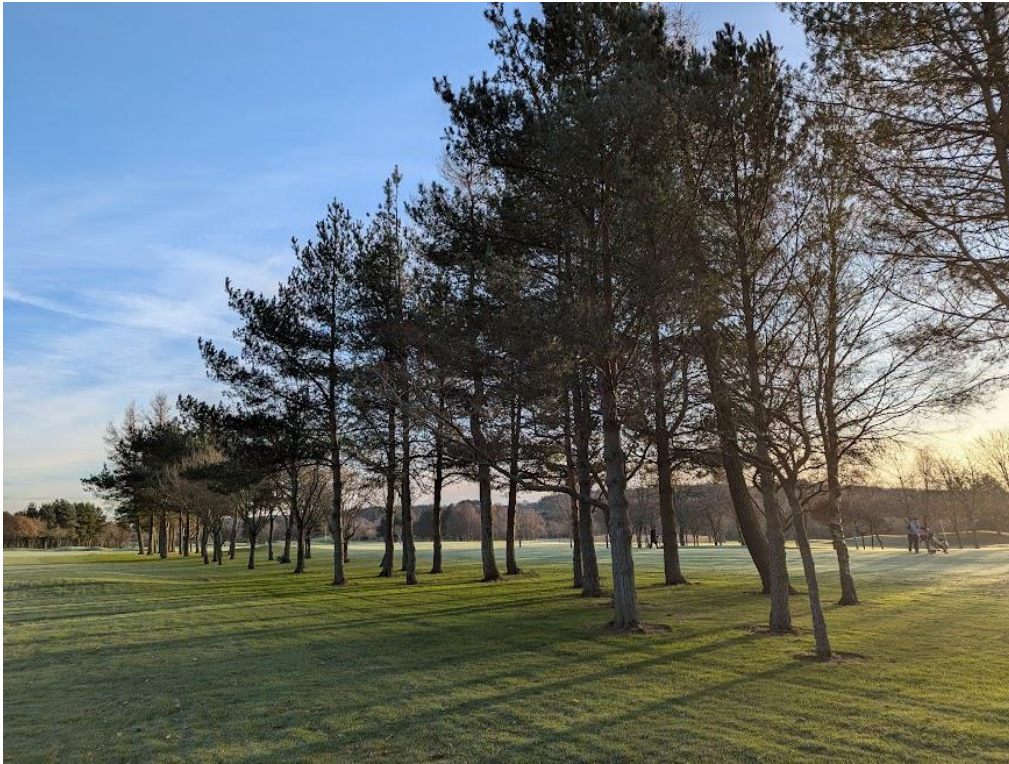
Photo 17 – Semi-mature Scots pine

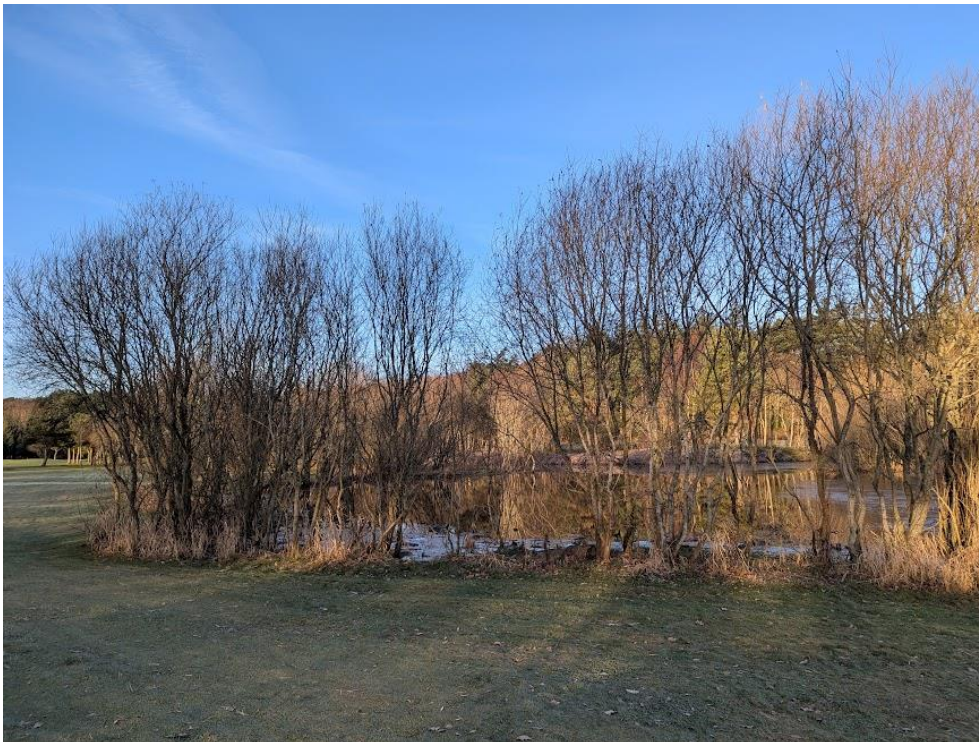
Photo 18 – Willow surrounding pond.

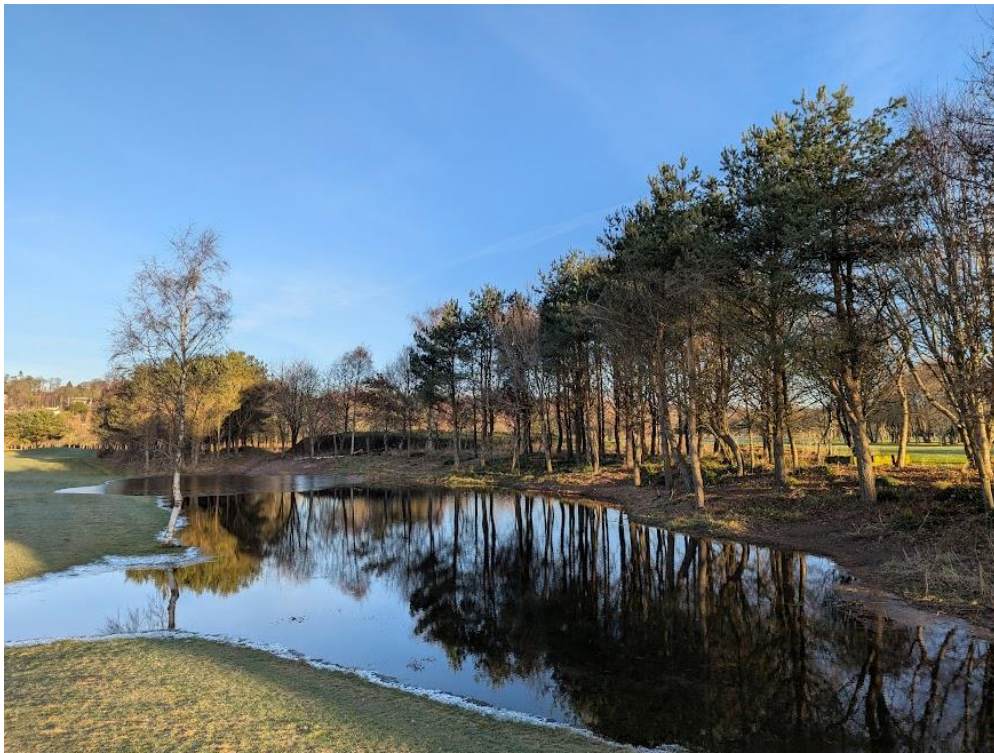
Photo 19 – Waterlogged soils will impact tree health.

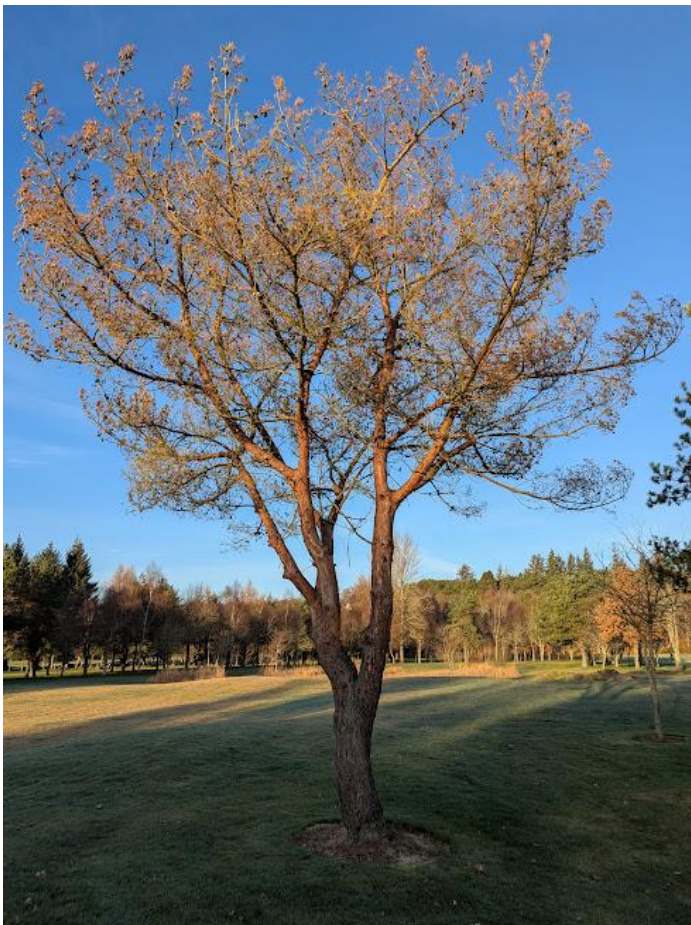
Photo 20 – Dead Scots pine 426. The small tree occurs at the edge of the fairway and is not a significant safety risk. Retaining deadwood can provide significant biodiversity benefit.
